Draft Environmental Assessment

Riverside Adventure Park Archery Facility
Indianapolis, Marion County, Indiana

Prepared For: Indy Parks and Recreation, Indianapolis, Marion County, Indiana

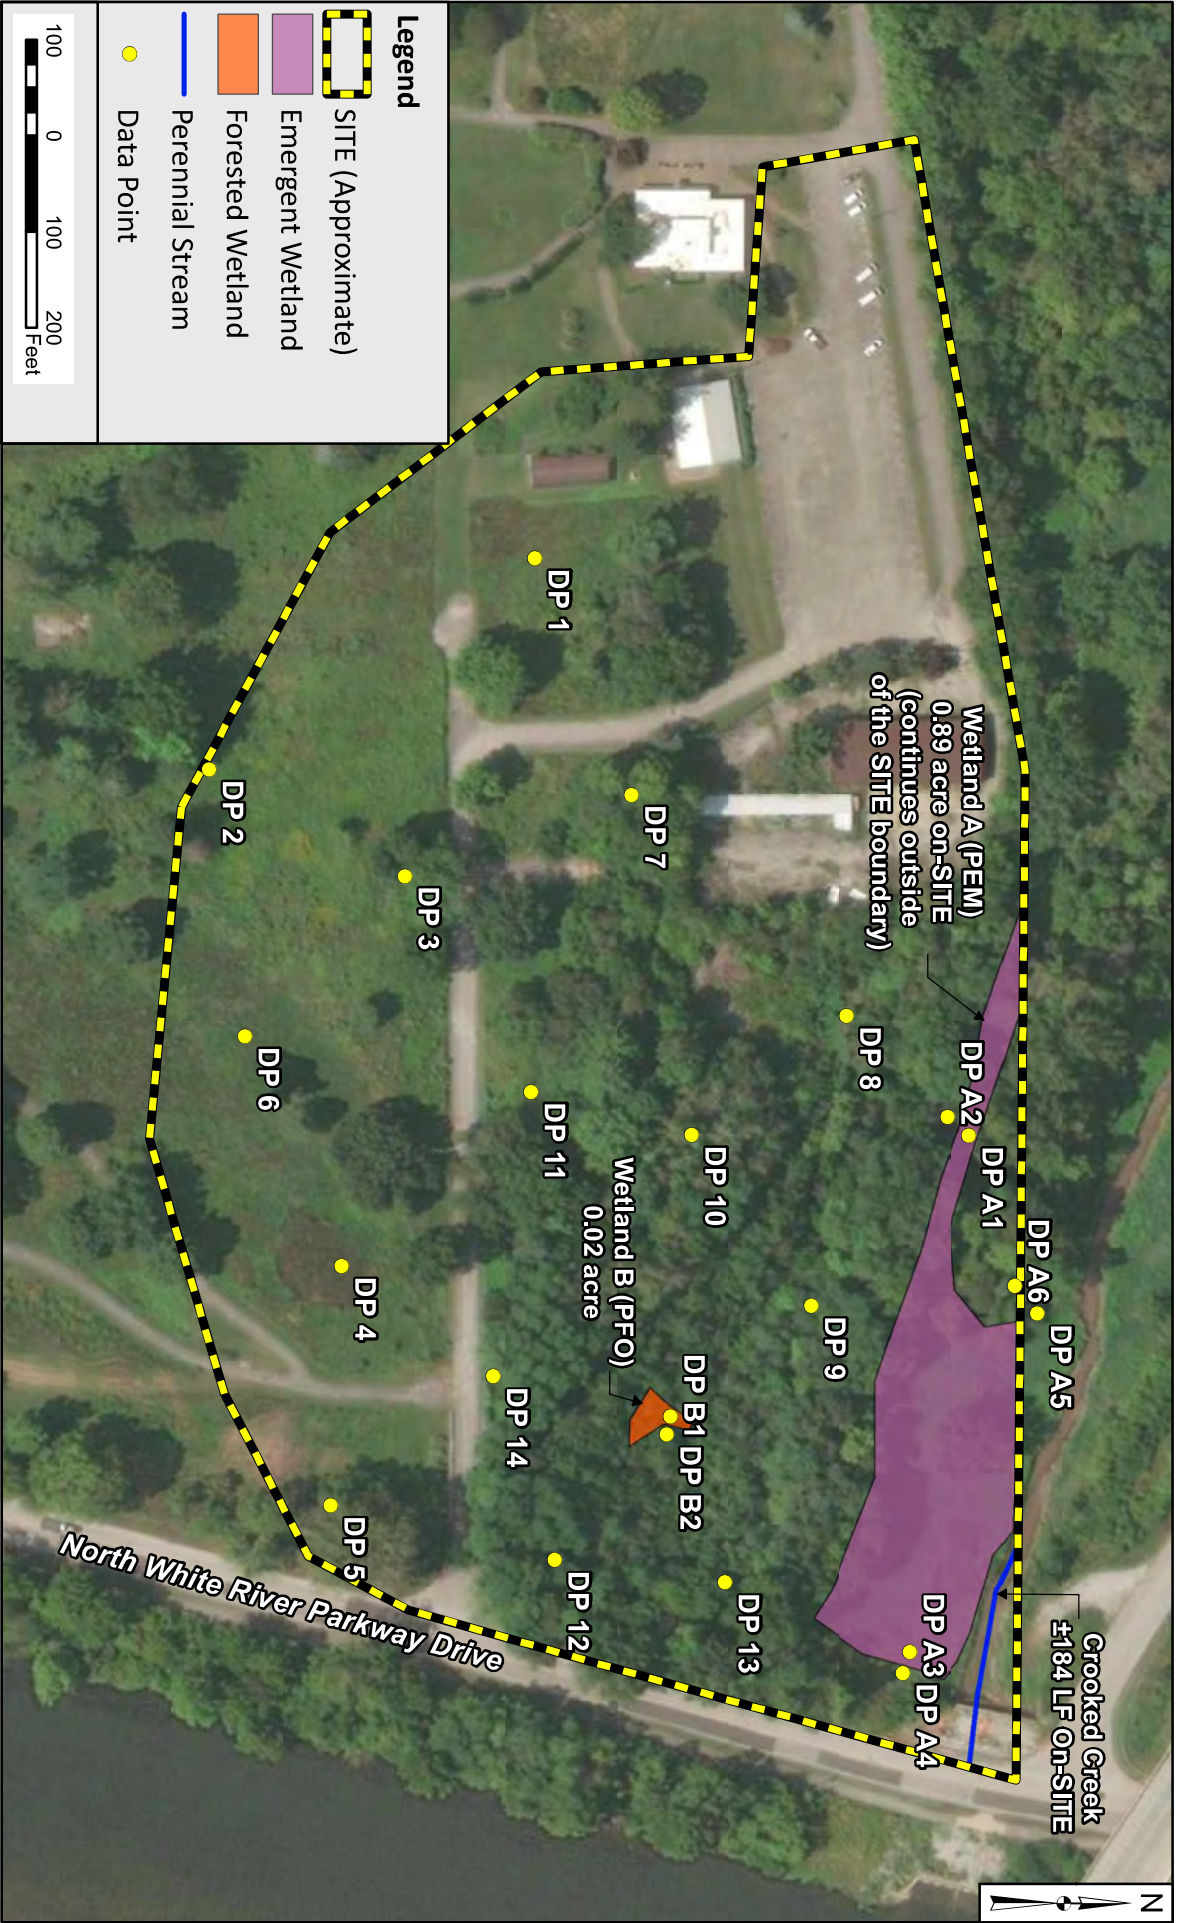
- SITE (Approximate)
- Emergent Wetland
- Forested Wetland
- Perennial Stream
- Data Point

A segment of Crooked Creek was identified within the SITE boundary. The segment was approximately 184 linear feet (LF) situated within the northeast corner of the SITE. Crooked Creek is a perennial stream, relatively permanent water, and “Water of the U.S.” subject to USACE and IDEM authority. The substrate in Crooked Creek appeared to consist of gravel, cobble, sand, and silt. In-stream habitat was minimal. No signs of water quality issues were observed.

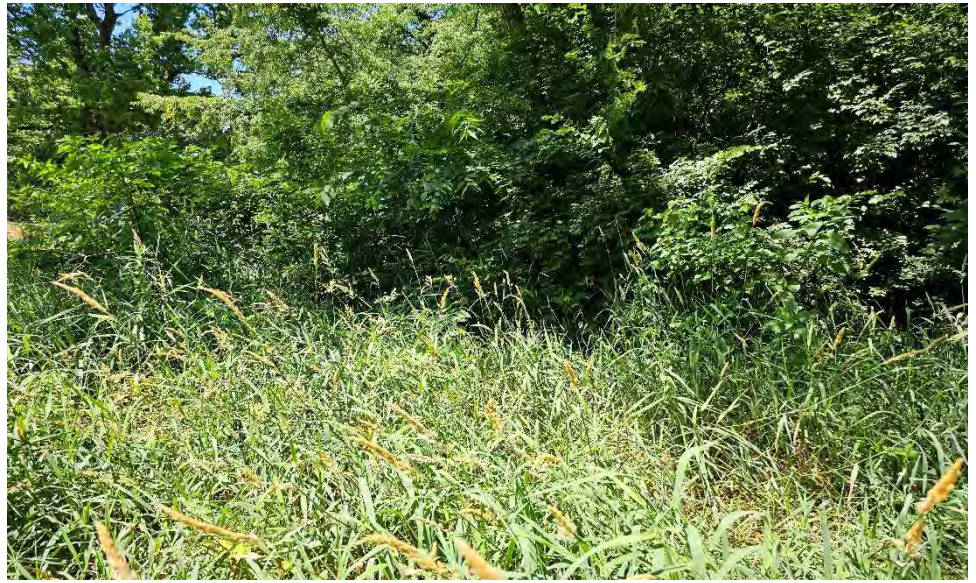
Photo: 80

Crooked Creek

The on-SITE segment of Crooked Creek is small, exhibiting no meanders or bends, and discharges into culvert pipes that convey flow under White River Parkway and into the White River. The substrate appeared to consist of silt, sand, and gravel. V3 staff scientists noted that riffle/run development was poor, and did not observe any in-stream aquatic habitat. The on-SITE segment of Crooked Creek provides minimal aquatic habitat.

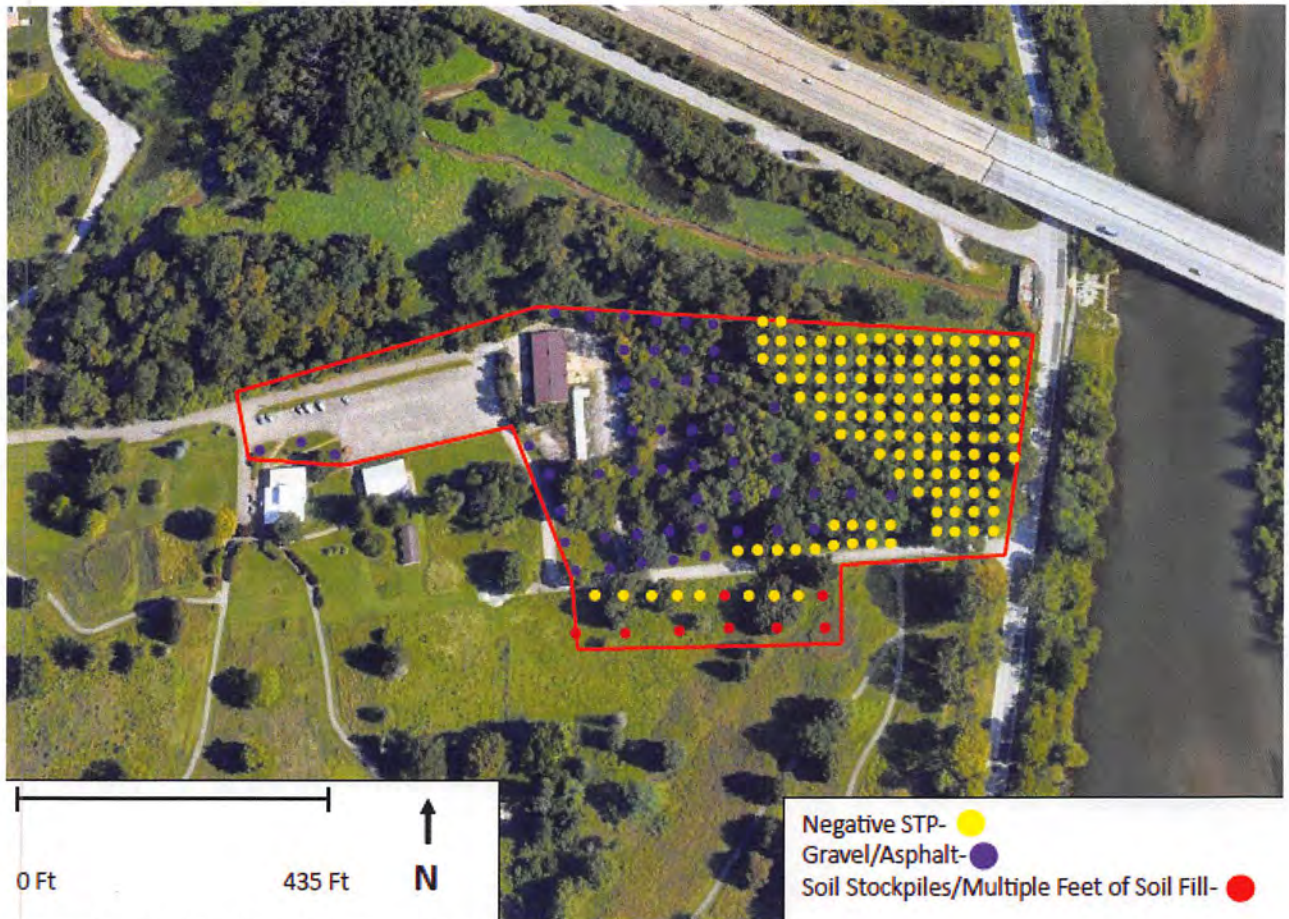
Figure 5. Aerial Map showing shovel test locations.

A Phase I archaeological investigation for the SITE was completed, with field reconnaissance occurring on 27 and 28 June 2024. This investigation detected no archaeological sites within the SITE boundary. A copy of the archaeological field reconnaissance report can be referenced in **Appendix C**. The authors of the report make specific recommendations related to on-SITE archaeological monitoring.

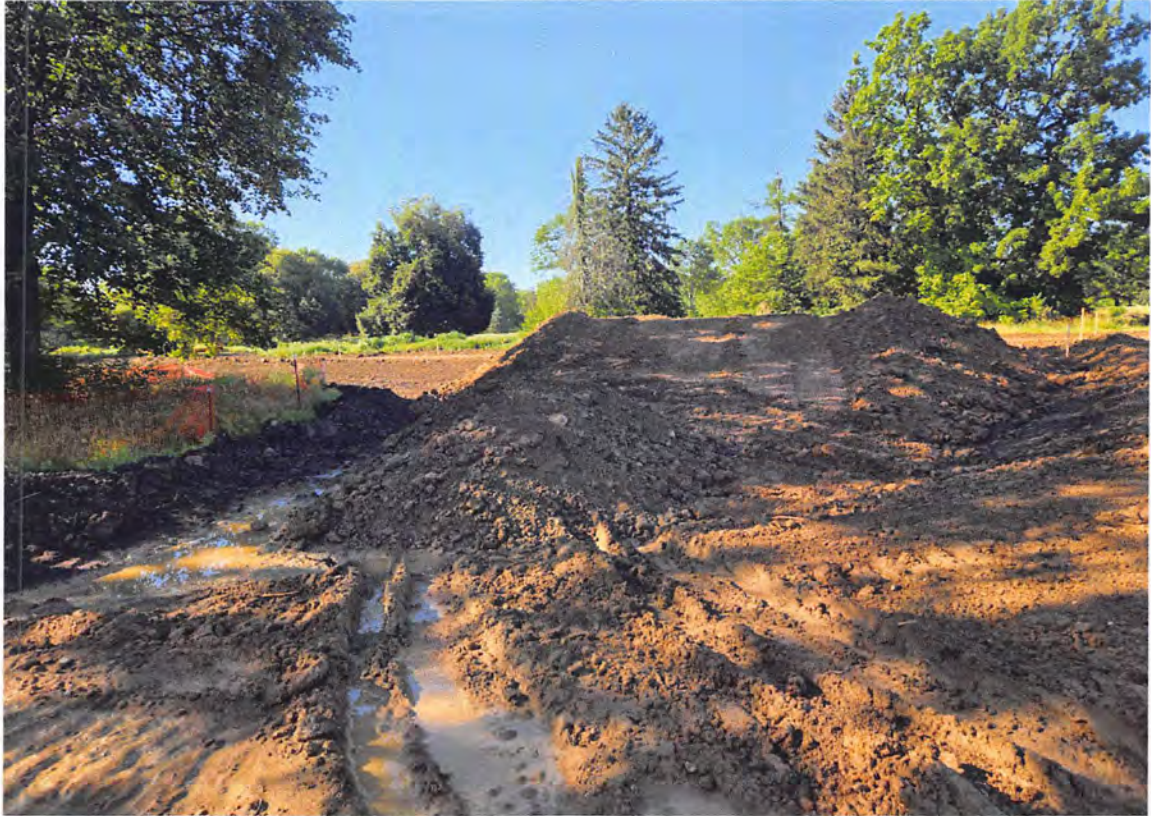
Figure 10. Spoil piles and grading activity in the southern portion of the project.

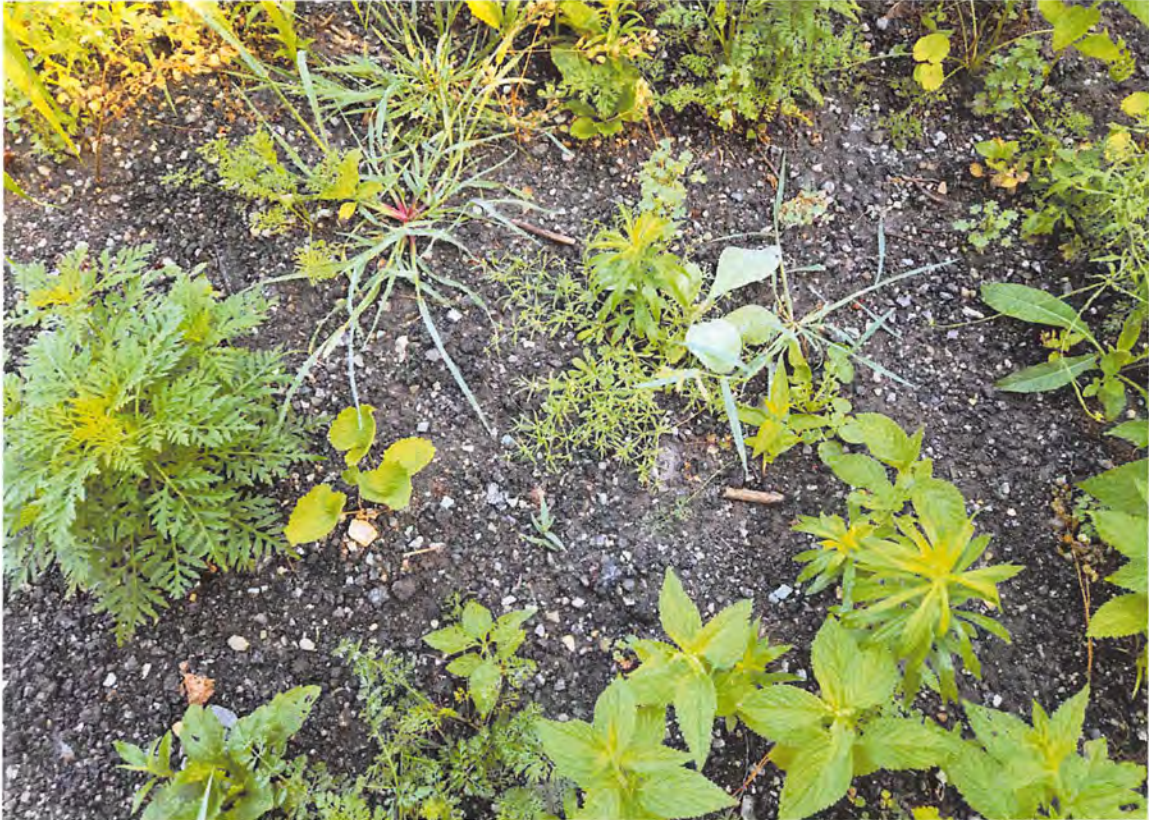
Figure 14. Asphalt spoil within the wooded portion of the project.

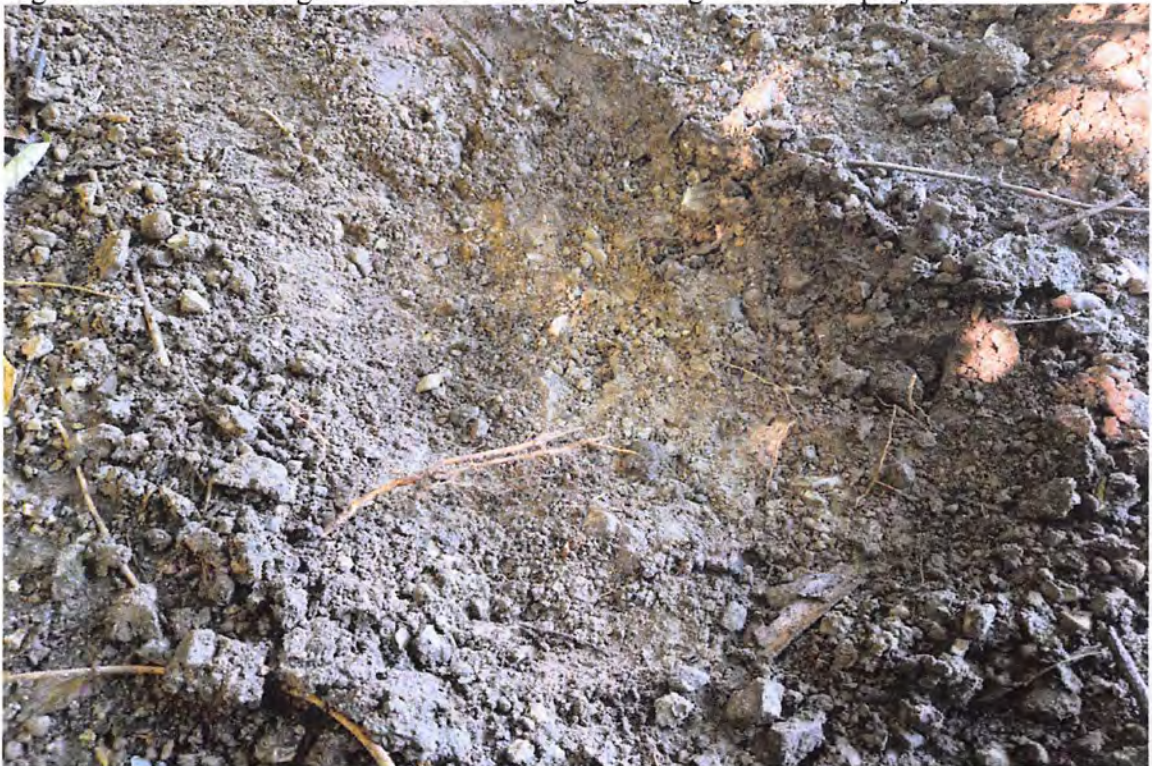
Figure 17. Gravel and asphalt mixed within soil within the woods.

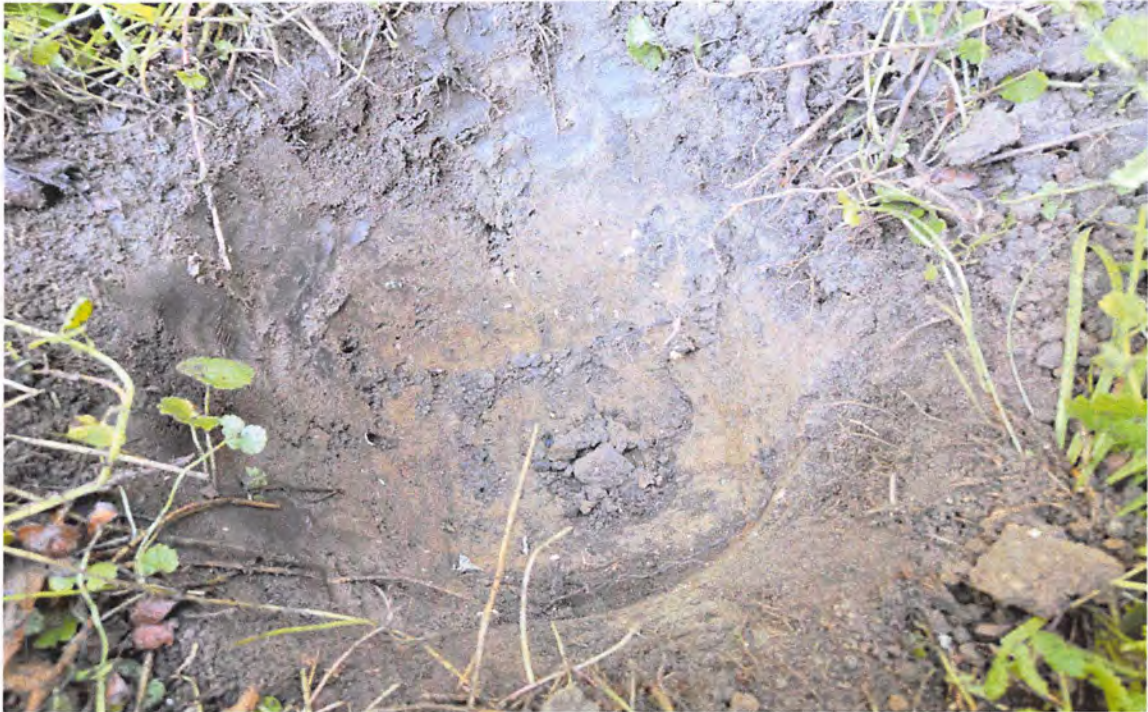
Figure 18. Shovel test in eastern portion of the project (note the concrete and gravel fragments within the soil).

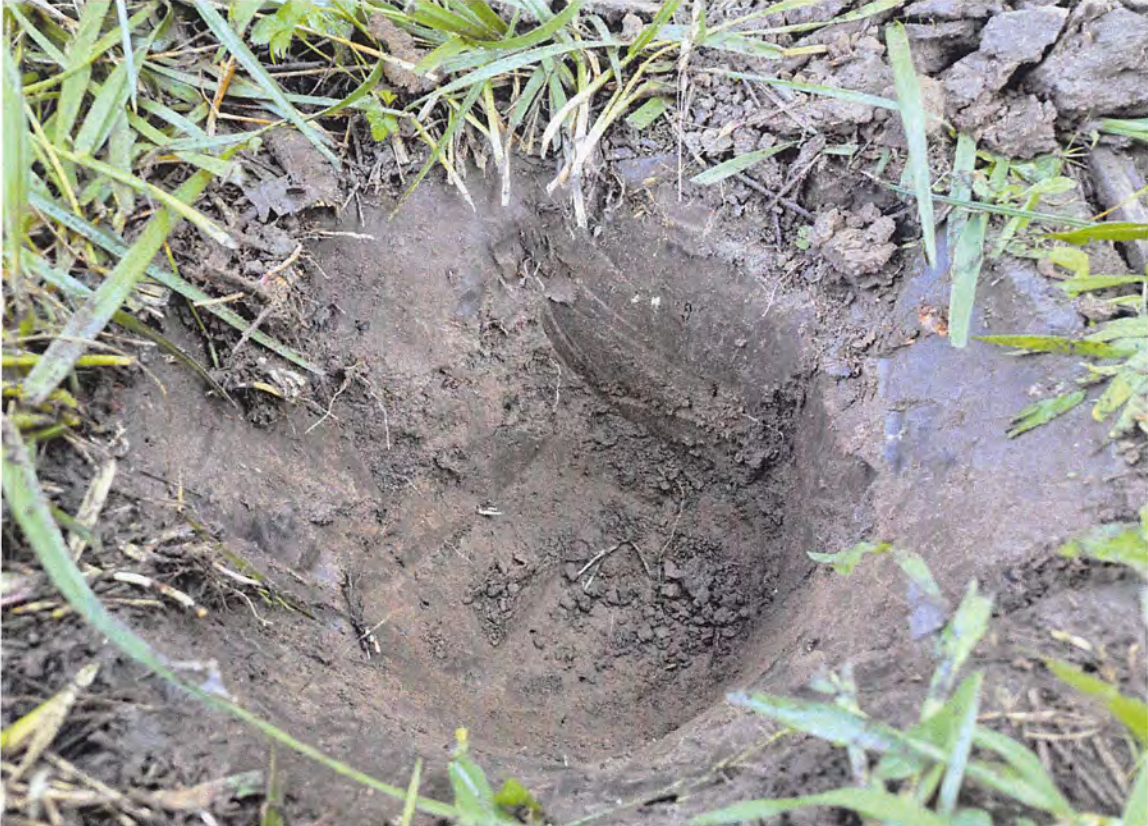
Figure 19. Another shovel test within the eastern portion of the project (note the dark spots within the soil from asphalt debris).
